Patio Refurbishment & All Paving Maintenance

Case Study

Marshall's Limestone Patio, Bolton, Lancashire

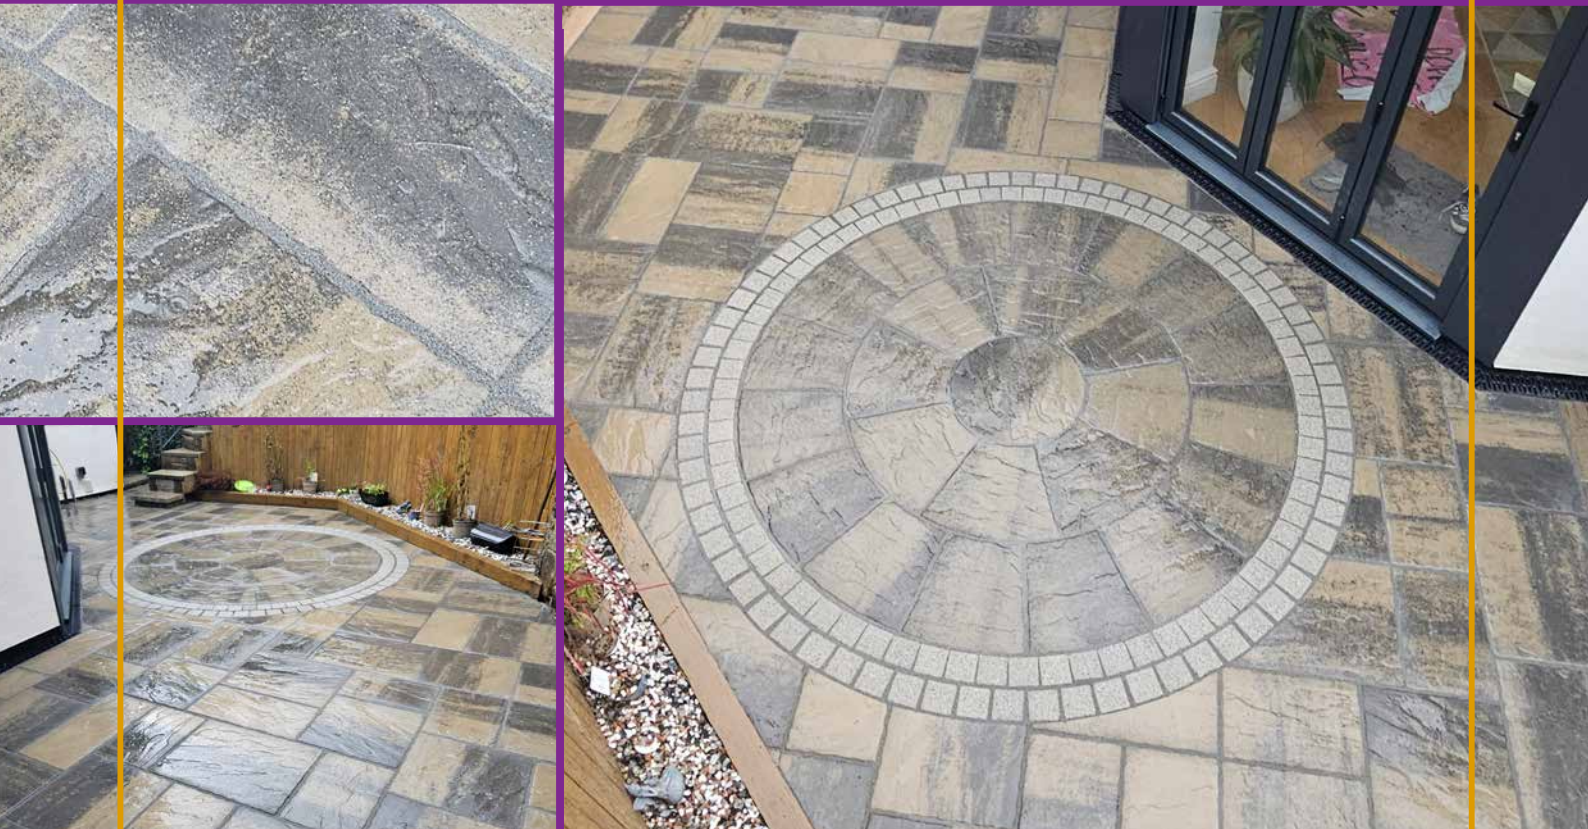
This stone circle and patio area at a private residence in Bolton, Lancashire, was laid using Marshall's limestone slabs and granite setts. It was only five years old and generally in good condition, but the pointing had already failed twice. The homeowners liked to keep their patio area in pristine condition, and used their jet-washer to keep it clean.

Luckily they contacted specialist paving contractors CR Services, who immediately recognised the cause of the pointing problems, and informed them that the 1-part jointing compound that had been used was not tough enough to withstand frequent direct jet-washing.

CR Services recommended the joints be cleaned and the pointing be replaced with GftK's vdw 850+, which is a 2-part epoxy paving joint mortar, supplied by NCC Streetscape, and ideal for natural stone paving. It is applied by wet slurry techniques, and will harden even in the cold and wet, ideal with the UK weather, and importantly, will fully resist regular jet-washing.

Prior to grouting, the area was again jet-washed and all the old pointing removed. It was then cleaned using NCC Black Spot and Green Growth Remover, before quickly repointing with GftK vdw 850+.
