Patio Refurbishment & All Paving Maintenance

Case Study

Large Sandstone Patio, Northwich, Cheshire

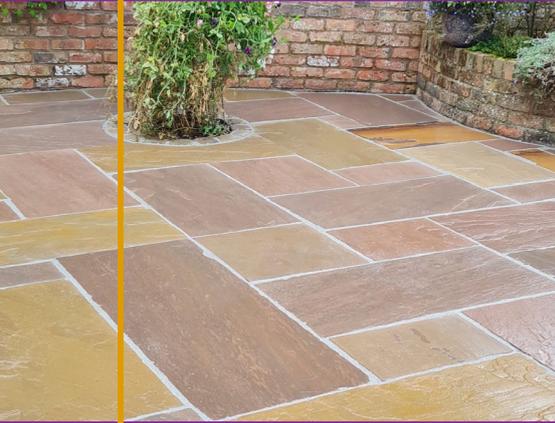
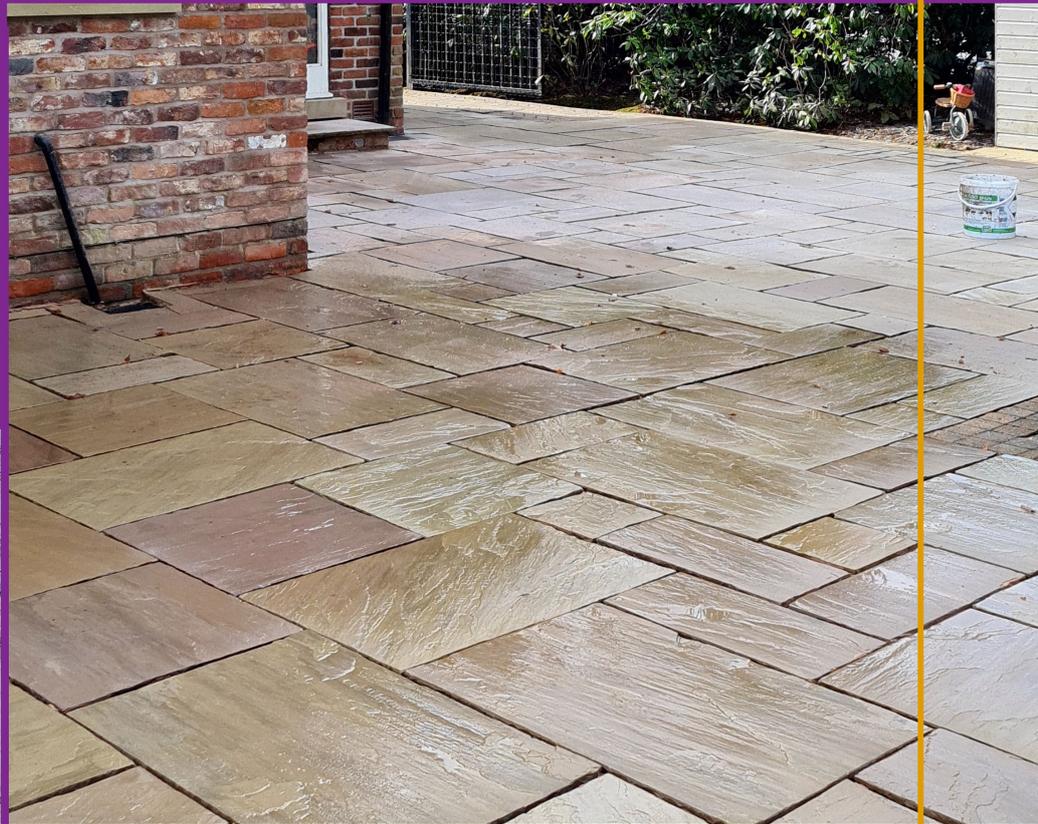
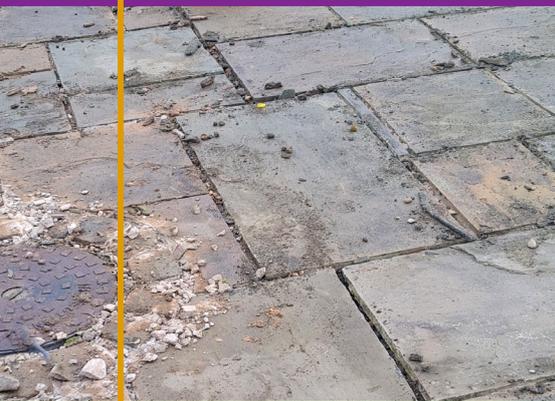
The large, very dirty sandstone patio and cobbled area at this private residence in Northwich was badly in need of refurbishment. The cement jointing mortar was cracked and failing and there was an extensive amount of difficult to remove, lichen 'black spots' in the surface pores of the slabs, completely spoiling the appearance of this once attractive area.

Specialist paving contractor CR Services were approached and recommended GftK's vdw 850+, a tough, non-staining, 2-part epoxy paving mortar, supplied in the UK by NCC Streetscape. Apart from its toughness, one of the advantages of vdw 850+ is the speed of application, a big plus for this extensive project, with the large patio covering more than 235m².

After remedial works to remove the old jointing, the paving was jet-washed and then the surfaces treated with NCC Black Spot and Green Growth Remover, which brought the natural stone back to its original beauty.

Although it was raining at the time booked for the job, this was no problem when using GftK's vdw 850+, as it is applied by wet-slurry techniques from a standing position, meaning that during application, the wetter, the better! In fact, despite the inclement weather, the whole project was completed in a week!
