# Patio Refurbishment & All Paving Maintenance

## Case Study

### Patio & Pathways, Oldham, Greater Manchester

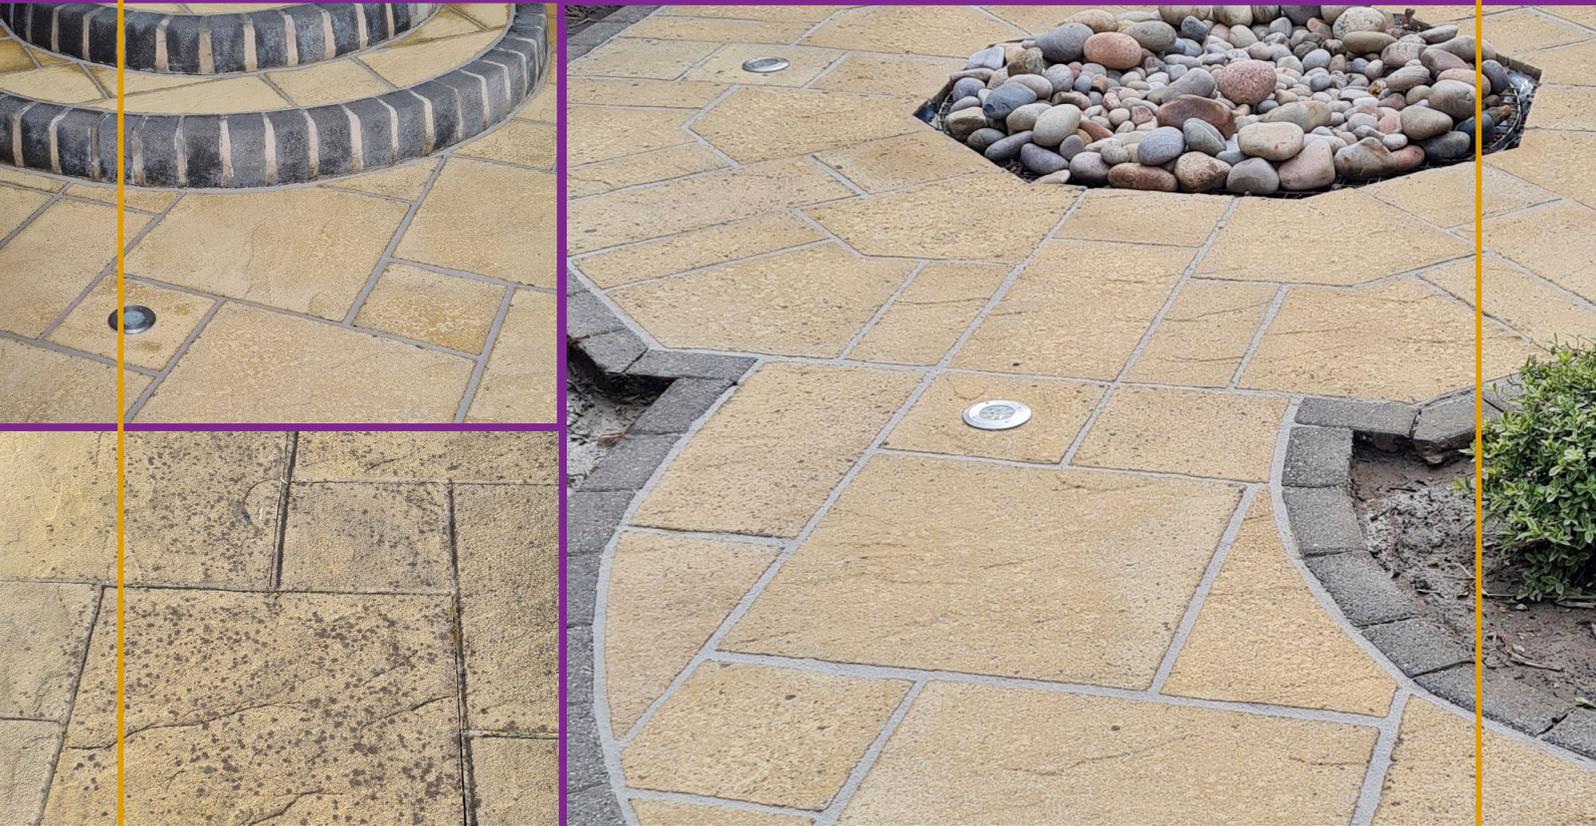
This intricately designed patio and path in Oldham had been down for many years and was in desperate need of some loving care! The reconstituted stone paving slabs were suffering badly from unsightly heavy grime and difficult to remove lichen 'blackspots', plus the original sand and cement pointing was cracked and failing.

Specialist paving contractors, CR Services were contacted and asked for advice and to provide the best solution to replace the failing mortar and to carry out the refurbishment. They advised replacing the failed cement mortar with GftK vdw 850+ paving joint mortar from NCC Streetscape, which is a high performance 2-part epoxy mortar, that is ideal for all types of paving, including reconstituted and natural stone.

Prior to application of GftK's vdw 850+, the CR Services crew removed all the defective concrete pointing and then the patio and paths were jet-washed and cleaned using high performance NCC Black Spot and Green Growth Remover.
