# Patio Refurbishment & All Paving Maintenance

### Porcelain Patio Refurbishment, Bury, Lancashire

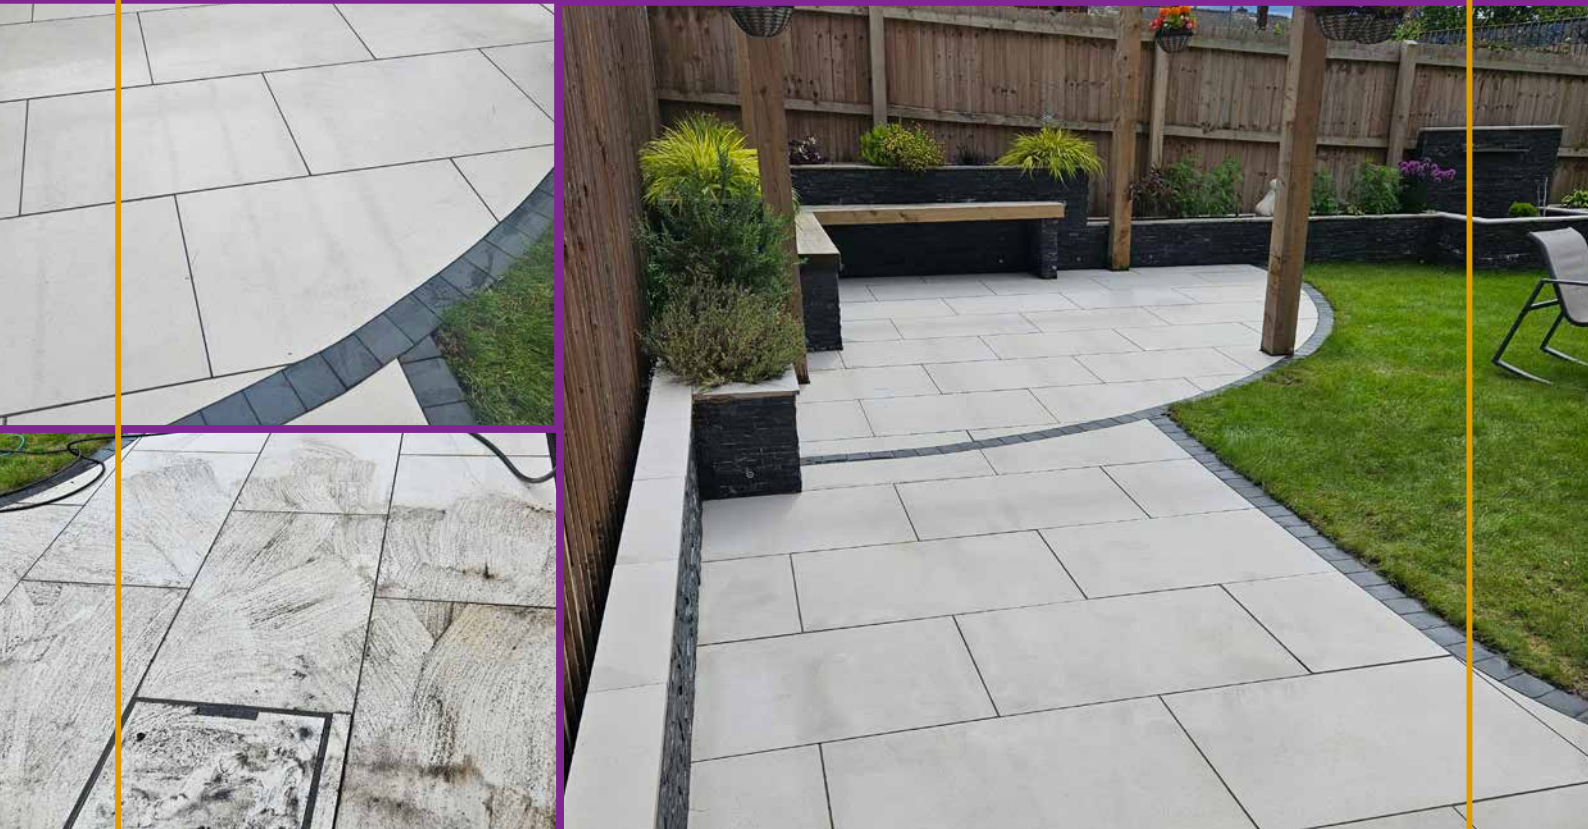
The owners of this private residence in Bury were disappointed that, although less than a year old, the original pointing on their white porcelain patio, with dark grey Brazilian slate sett edging, was already failing and coming out. Also the jointing compound used for the pointing had left unsightly staining to the edge of the tiles, giving an unwanted 'picture frame' effect.

They contacted specialist paving contractors, CR Services, who immediately knew exactly what to do to remedy the situation! Firstly they jet-washed the patio to remove most of the failed jointing, and any remaining residue was brushed from the joints. The porcelain slabs were then cleaned with NCC Porcelain Intensive Cleaner which removed the staining from around the tile edges.

The CR Services crew regouted the porcelain patio with GftK's vdw 815+, a 2-part, high performance, non-staining, paving jointing mortar, especially designed for high performance in narrow joints. This also resistant to frequent jet-washing.
