Patio Refurbishment & All Paving Maintenance

Case Study

Indian Sandstone Patio, Wilmslow, Cheshire

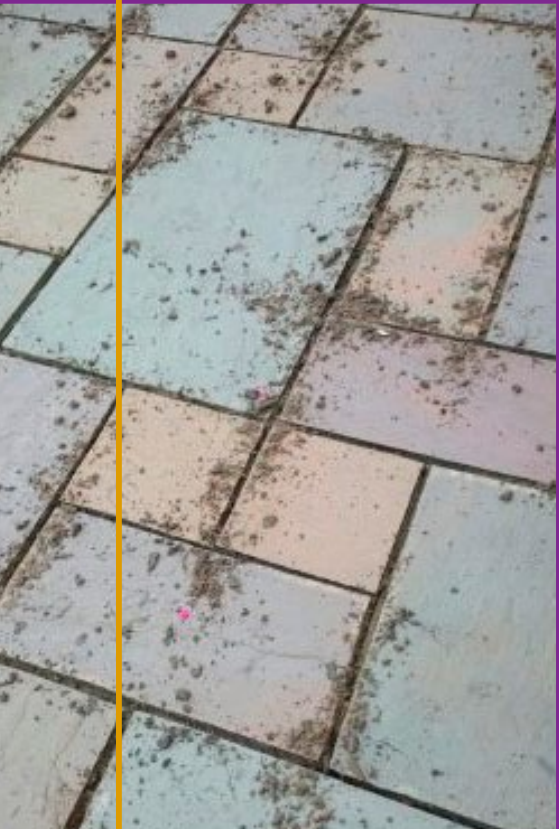
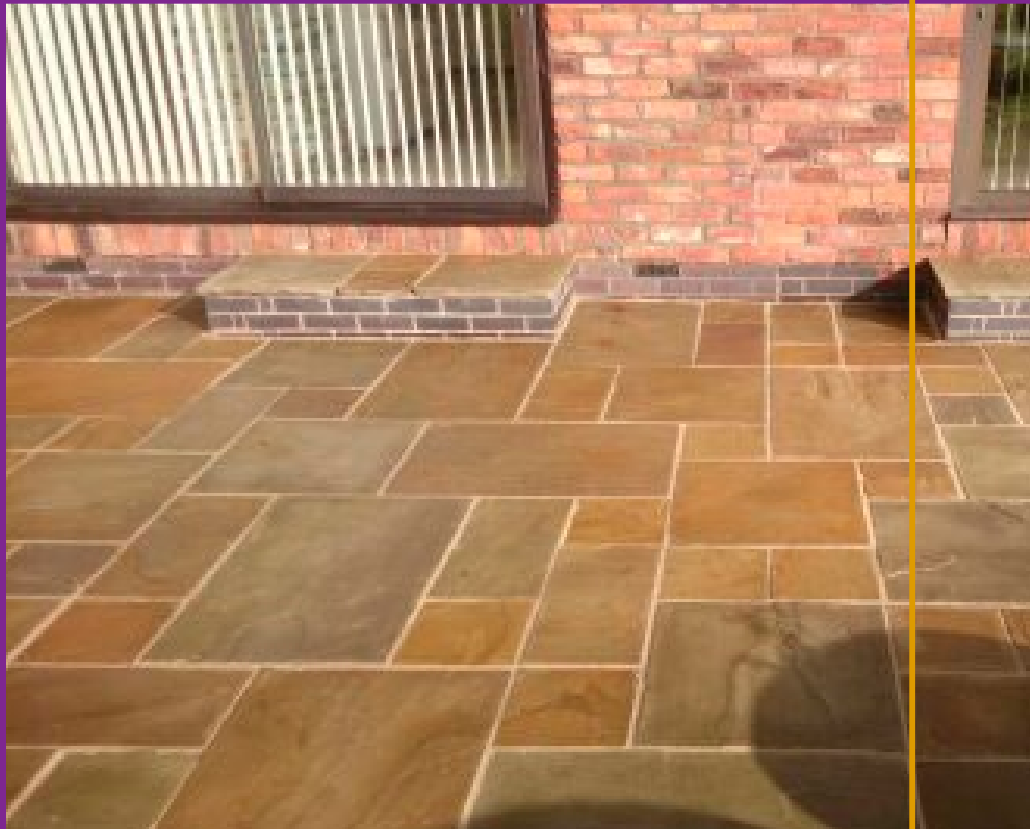
These Indian Sandstone Patios and Pathways were a lovely colour, but after only two years' service the original sand and cement pointing was literally crumbling away – most likely due to residual water changing the original water:cement ratio in the joint leading to cracking and frost damage – difficult to avoid with cement materials in the UK weather.

CR Services knew just how to fix this problem by replacing the failing sand and cement grout with a 2-part epoxy based paving joint mortar from NCC Streetscape. This is wet slurry applied with even more water and therefore not sensitive to the unpredictable and changeable British weather.

The surfaces were first cleaned using NCC Black Spot & Green Growth Remover, the old cement joint mortar was removed and the new epoxy paving joint mortar applied.
