Patio Refurbishment & All Paving Maintenance

Case Study

Yorkstone Driveway & Patio, Nantwich, Cheshire

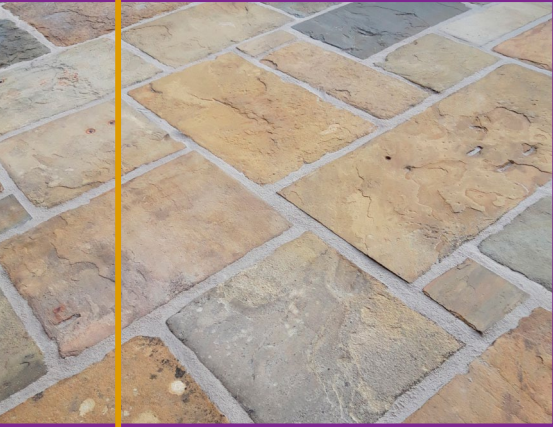
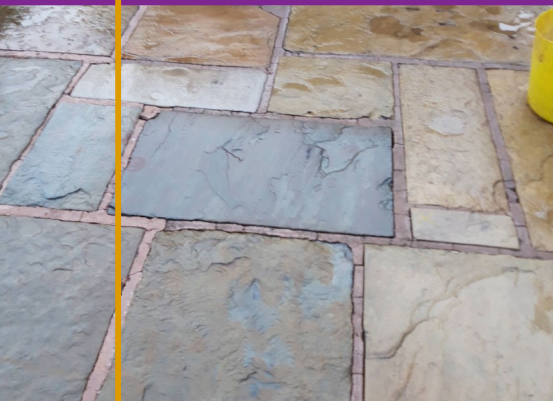
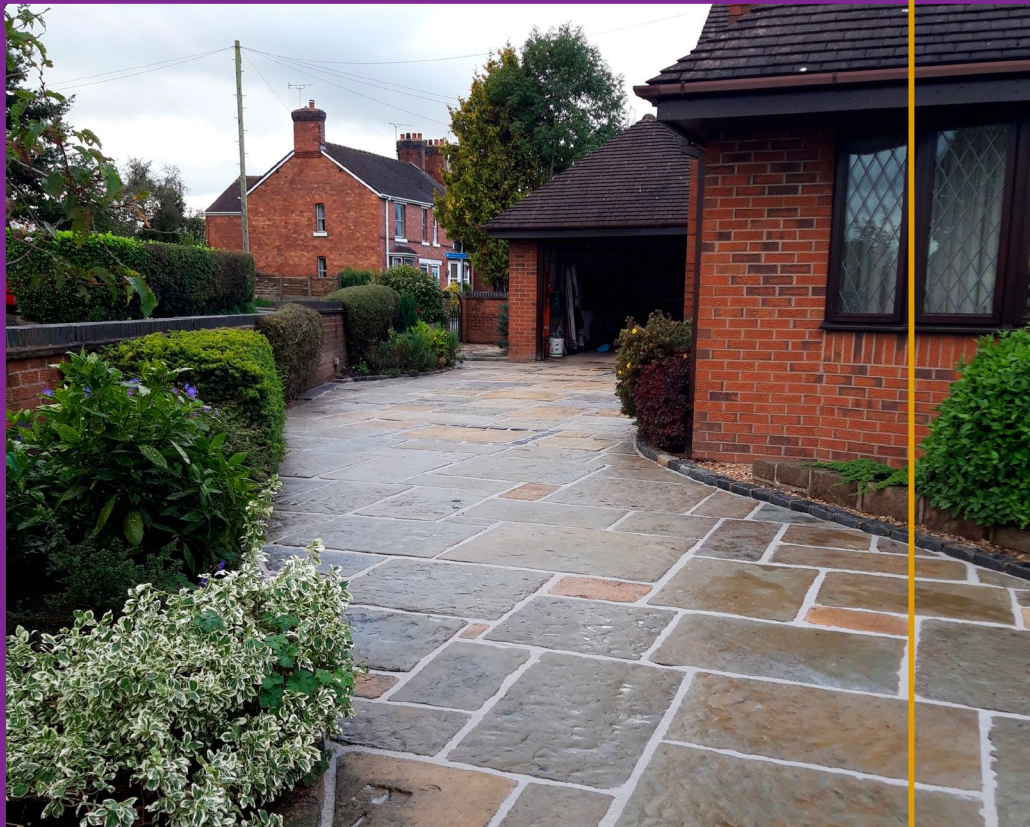
This substantial natural Yorkstone driveway in Nantwich, together with a patio and pathways, was looking extremely tired with the original sand and cement grout cracking, and in some areas, coming out completely and leaving unsightly gaps. Looking to refurbish these areas, the homeowners did considerable on-line research to find a reliable paving contractor, who would replace the failed grouting with a high performance paving mortar, capable of withstanding the continual movements of the family vehicles.

The crew from specialist paving contractors, CR Services, raked out the old failed jointing and all areas were jet-washed and cleaned using NCC Black Spot & Green Growth Remover, which removes unsightly green staining and the hard to remove black lichen deposits.

Following their research, they contacted paving specialists CR Services, who recommended GftK vdw 850+, a high performance, non-staining, 2-part epoxy paving mortar from NCC Streetscape. This is tough and durable and well capable of withstanding the heavy loadings and exposure to deicing salts etc. on the driveway.

The homeowners were delighted with their finished patio and in particular the driveway, which can now be used safely without fear of being damaged by the family cars in the future.
